Inspection of Submerged Structures

Antonio Vasilijevic¹, Nadir Kapetanovic², Nikola Miškovic³

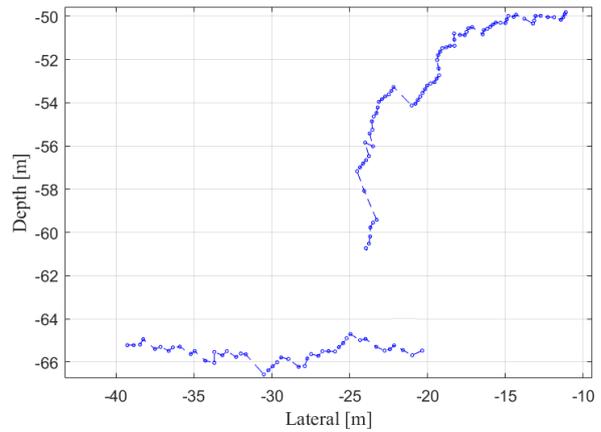
Fig. 4 presents one lateral profile of the shipwreck where the gap between the seabed and hull exist. Seabed is relatively flat on the depth of approximately 65 m while hull is clearly lifted up. The point cloud of this lateral profile allows us to measure the gap pretty accurately. In this particular case, we estimated the gap width to be 4 m.

Fig. 4 One multibeam profile over the part of the wreck where the gap between the hull and seabed exist

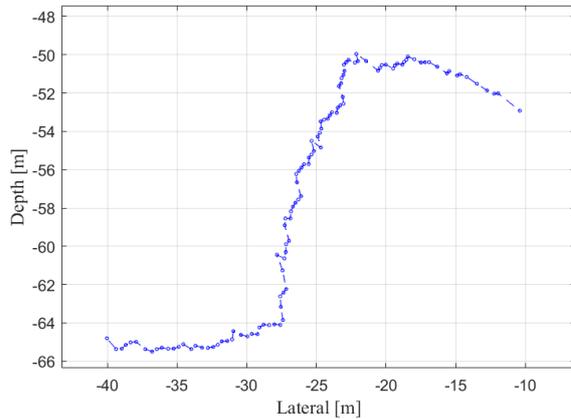
Fig. 5 One multibeam profile over the part of the wreck where gap is closed

At contrary, Fig. 5 presents the lateral profile where the gap does not exist. Analysing the point cloud, we can see that measurements form the continuous line i.e. there is no interruption at the transition between the seabed and the hull, meaning that there is no gap.

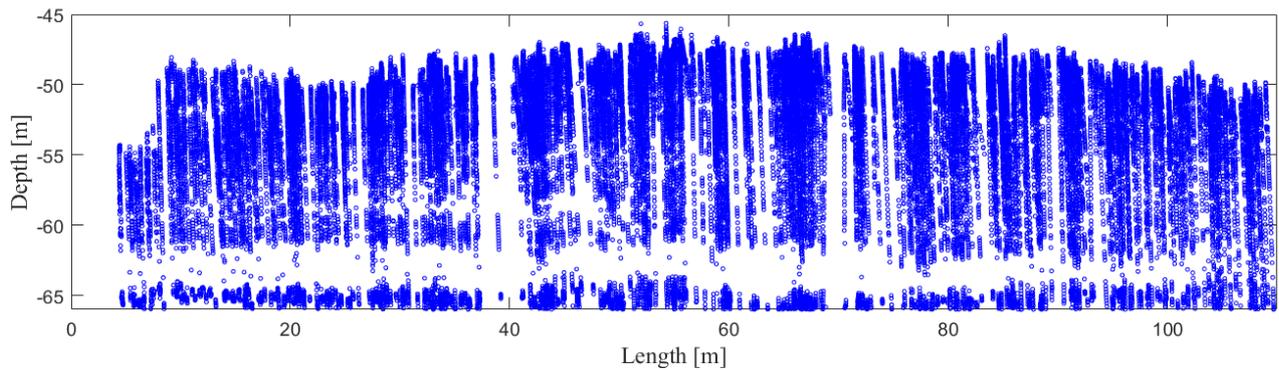
Fusion of all profiles gives us complete picture of the inspection site. The result is shown in Fig. 6 and presents the side view of the complete shipwreck side. Here we can see that gap exist all the way from the stern end of the ship (5 m in local reference frame) to the position of 105 m in a local reference frame i.e. the gap is approximately 100 m long. What we can also notice is that gap has different width along the wreck side. Analysing and measuring the gap profile by profile we concluded that gap varies is size from as less as 2 m to up to 4.5 m. Average gap width is close to 4 m i.e. it is 3.8 m. Fig. 7 shows zoom-in on the one part of the inspection area where gap is clearly distinguishable and easy to measure.

Fig. 6 The result of the multibeam sonar scanning of the inspection area. Image represents 2D side view of the shipwreck. Y-axis represent the depth while x-axis represent the distance in meters from the local origin.

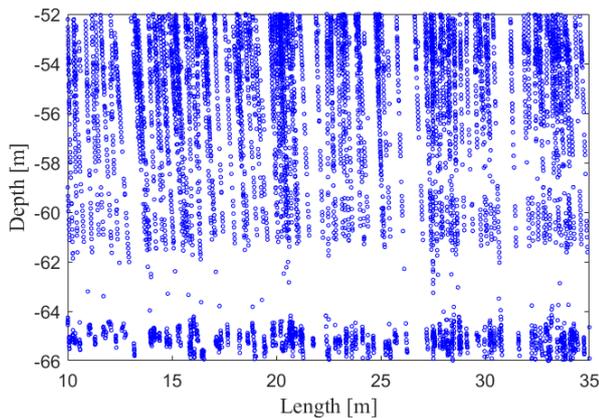
Fig. 7 Selected part of the shipwreck where gap exist. Outliers in the gap area are clearly noticeable.

There are two interesting points to mention here. First, it is evident that lateral profiles are not distributed evenly along the shipwreck. It can be easily explained by the fact that ASV carrying the sonar was rolling slightly on the waves which in result affected the directional stability of the sonar and acoustic beams. However, it did not compromise the reliability of measurements because the lateral profiles are geo-referenced based on both ASV GNSS position and sonar attitude measurements, but it still caused an uneven distribution of lateral profiles. The second is the fact that some points/measurements are visible on the area where the gap exists, both on Fig. 6 and Fig. 7. Our first thought was that these are measurement outliers, but the fact that there were substantial number of them forced us to perform deeper analysis taking into account all data collected in the scope of the survey. What has been noticed from the video footage of the wreck was that shipwreck was completely covered by ghost fishing nets that were stuck there over the years (Fig. 8). Furthermore, nets mesh was often clogged by biofouling which could easily reflect the acoustic signal

and cause the sonar echo. We believe that this is the reason for the significant number of outliers in the gap area where we do not expect them to be.

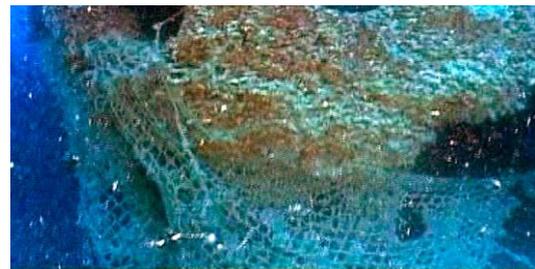
Fig. 8 Image captured from the video footage shows some of the ghost fishing nets covering the shipwreck
