Non-invasive and Micro-invasive Investigations on Wall Paintings from a XIII century Temple in Bagan Valley (Myanmar)

Maria Letizia Amadori¹, Mara Camaiti², Valentina Raspugli¹, Yoshifumi Maekawa³, Ko Kyi Lin⁴

In February and July 2017, a scientific survey concerning XIII centuries wall paintings of temple Me-taw-ya, located in the south of Myinkaba village in Bagan site, carried out. It was supported by Tokyo National Research Institute for Cultural Properties (TNRICP).

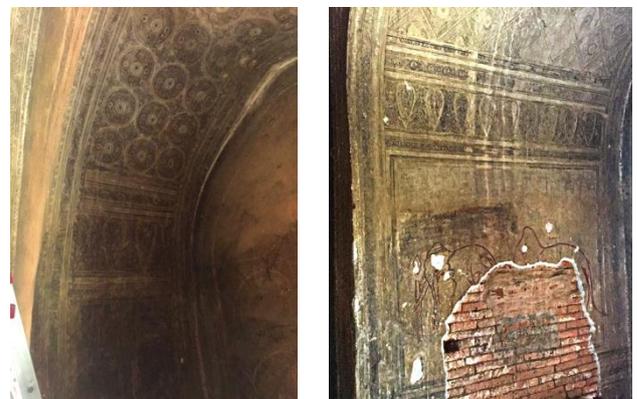
Fig. 2. Wall paintings in temple Me-taw-ya

The mural paintings decay was mainly caused by rainwater infiltrations because the roof was seriously damaged. Nests, insects, animal excrements as well as, flaking, graffiti, tarnishing of adhesives from previous restorations were found too.

The wall paintings colours are mostly whitish or yellowish with dark black, grey and red purple tones (Fig. 2). Probably a pigments discoloration was gone on and the original painting layers were bright-coloured but the decay changed them inexorably.

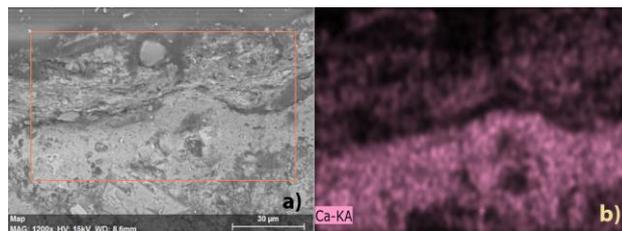
Fig. 3. MY31, SEM micrograph

An overlaying finishing carbonate/oxalate layer (level 1, thickness 25 μ) is present, sometimes containing As-based fibrous particles too (fig. 3).

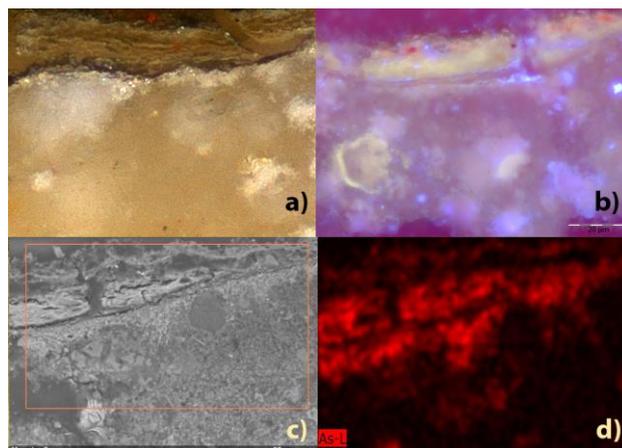
Fig. 4. Sample MY33: Optical microscope micrograph: (a) visible light; (b) UV light; (c) SEM micrograph; (d) As elemental map distribution (EDS)

In reddish tones (MY33), EDS element maps (Fig. 4) revealed the abundance of arsenic whose distribution has no correspondence with sulphur. Calcium, silicon, iron, aluminium, titanium, magnesium, carbon, chlorine and sodium have homogeneous distribution. An additional paint layer (level 3) in sample MY33 was observed. SEM-EDS revealed the presence of some Ca and As-rich particles as well as cinnabar and phosphorous, sodium and chlorine traces.

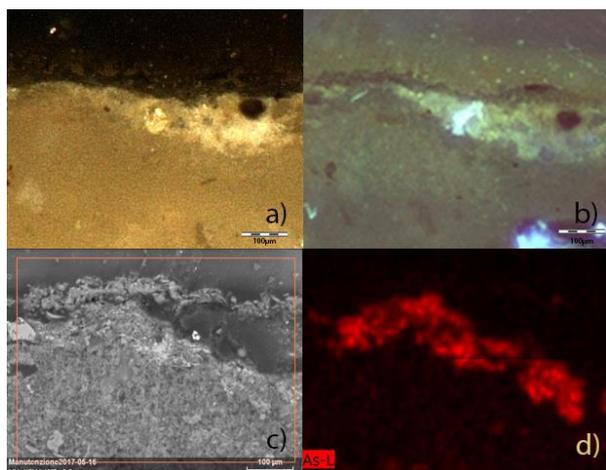
Fig. 5. Sample MY45e: Optical microscope micrograph: (a) visible light; (b) UV light; (c) SEM micrograph; (d) As elemental map distribution (EDS)

In brownish tones (MY32 and 45e) optical microscope investigations revealed a whitish paint layer (level 1). SEM-EDS elemental map revealed high calcium and arsenic amounts probably related to Ca and As-based (fig.5) compounds, as well as iron oxides silicates and chlorine traces. In the overlaying layer (level 2), SEM-EDS elemental map revealed the presence of silicon, aluminium, potassium, iron, phosphorous, and As-based particles (MY32, level 3). In My 45e cinnabar presence was detected.

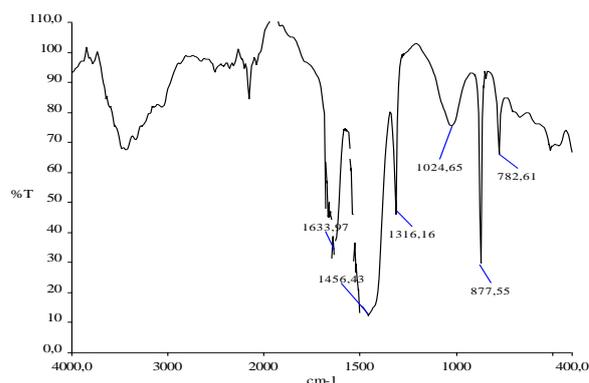
ATR/FT-IR performed on My33 sample (level 0) detected calcium carbonate, calcium oxalate monohydrated and traces of silicates, confirming the high content of calcium in SEM-EDS analysis (fig. 6). The presence of oxalate can justify the use of lime mixed with a natural organic material as binder. The two painted layers (level 1 and 2) are composed by calcium oxalates (mono and bi-hydrates), calcium sulphate (as gypsum)

Fig. 6. FTIR spectrum of the white binder (level 0) of the sample MY33.

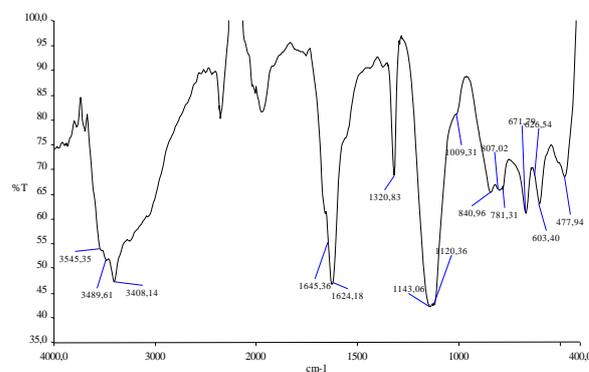
Fig. 7. FTIR spectrum of the grey superficial layers (levels 1 and 2) of the sample MY33

and arsenic based compounds (mainly arsenolite, orthoarsenates and orthoarsenites such as Fe(III)-orthoarsenite), traces of silicates (Fig. 7). Gypsum was detected only on the superficial layer.

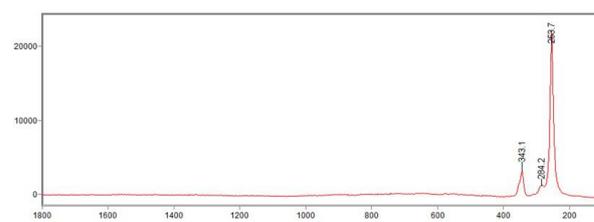
Fig. 8. Raman spectrum of MY45e

μ -Raman pointed out an intense Raman fluorescence in painting layers, maybe due to some organic compound. Carbon black (sample MY33), magnetite (sample 44), goethite and cinnabar (sample 45e, fig. 8) were detected.
