# Diagnostic Survey on Frescoes Paintings in Pompeii by Active IR-Thermography

**Abstract** – This paper shows the first results of a diagnostic survey of the fresco paintings in two *domus* of the *Region V* in Pompeii, the *Domus* of *C. Iulius Polybius* and the *Domus* of *Casti Amanti*, which stand out for archaeological relevance and decorative asset. Especially, these cases of study were selected because pose special challenges for damage detection and conservation, due to the presence of large parts of not excavated soil behind walls and frescoes painting surfaces.

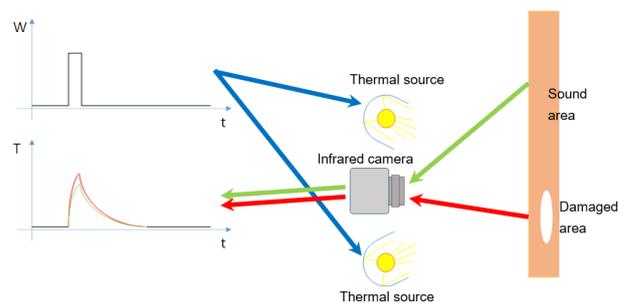
Fig. 1 Active thermography set-up

Fig. 1 shows the test procedure:

- the thermal source, which in most cases is a series of halogen lamps or flash depending on the duration of the thermal pulse, produces an impulsive heating represented by the W-t time history;

- the damaged sample (e.g. with a surface-substrate detachment) warms up when the lamps are switched on and cool down when they are switched off according to an exponential function that will have different exponents depending on whether the camera frames the sound or damaged zone. The different exponential raising and decay is evident in the thermal time histories T-t. The red time history refers to the damaged area, the green one to the sound one.

1. in reflection mode: source and camera are positioned at the same side of the sample surface, see Fig. 1;
2. in transmission mode: source and camera are positioned on the opposite sides of the surface to be investigated.

The thermal source exploited in the Pompei test case consists of three halogen lamps whose power does not emit a significant amount of energy. In addition, because some of the frescoes, like the ones of the *Domus of Casti Amanti*, have been recently restored their surface

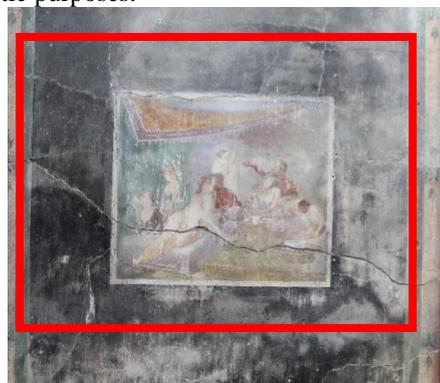
Fresco photograph (P IX 12 9 m N)

The PCA results are synthesized in Fig. 2, where the fresco P IX 12 9 m N picture is reported together with a thermogram at a specific time sample and the first two PCs, the only ones containing useful information for diagnostic purposes.

Fig. 2 PCA results for fresco P IX 12 9 m N

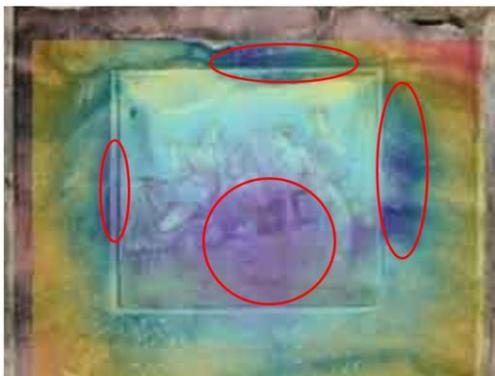
Fresco P IX 12 9 m E

As final result, the first PC has been superimposed to the visible picture of the three frescoes in order to evidence the eventual damaged regions highlighted in red in Fig. 3.

Fig. 3 Diagnostic map of the three Casti Amanti frescoes

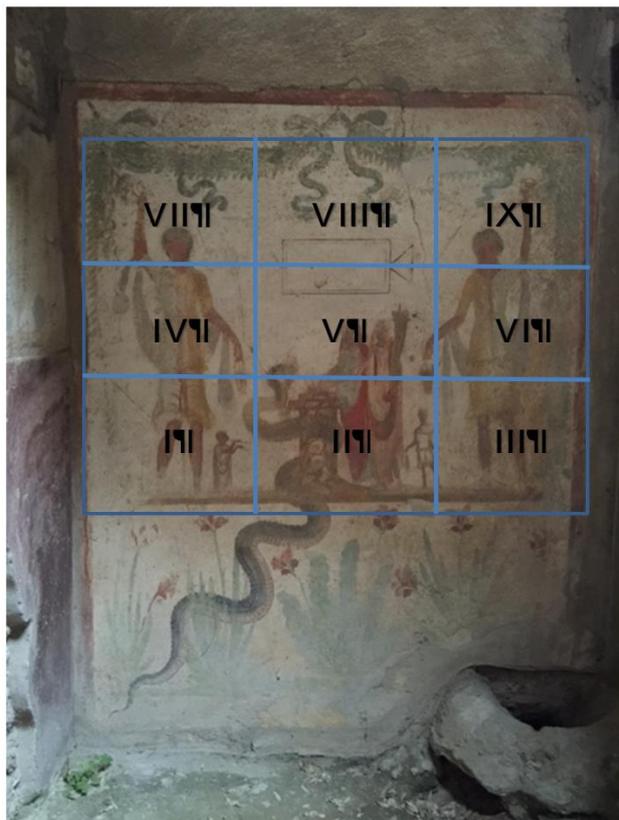
Fig. 4 Partition numbering of the Iulius Polibius fresco (P IX 13 3 3c O)

Being the fresco of the *Domus of Iulius Polibius* rather big, it has been partitioned in nine portion in a 3x3 rectangles, as reported in Fig. 4.

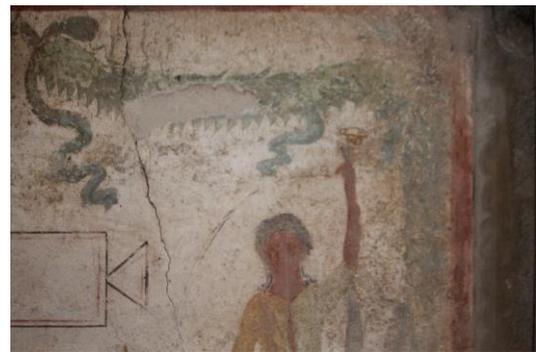
Fresco partition IX photograph

As in the previous section, the PCA results are synthesized in Fig. 5 only for the partition IX, where the partition picture is reported together with a thermogram at a specific time sample and the first two PCs.

Fig. 5 PCA results for fresco P IX 13 3 3c O, partition IX

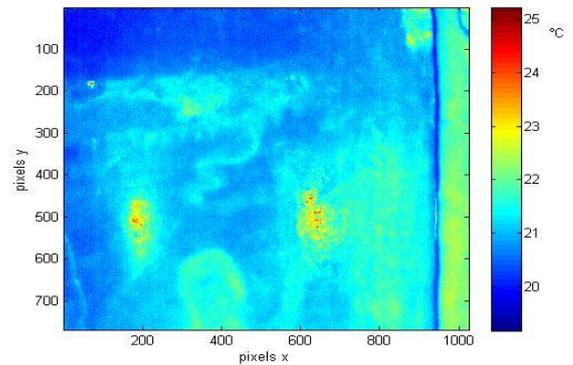
Thermogram at 59 s

In this case it is visible that the thermogram is influenced by both the heating inhomogeneities, i.e. the lamps light reflections are the two yellow spot in the thermogram at 59 s, and the surface colors, i.e. the woman head and the snake tail are easily distinguishable. The PCA is helpful in separating the different chromatic and reflective contributions, which are mostly concentrated in the second PC. The first PC instead is not influenced by those interfering inputs and can be used for more accurate diagnostic purposes.

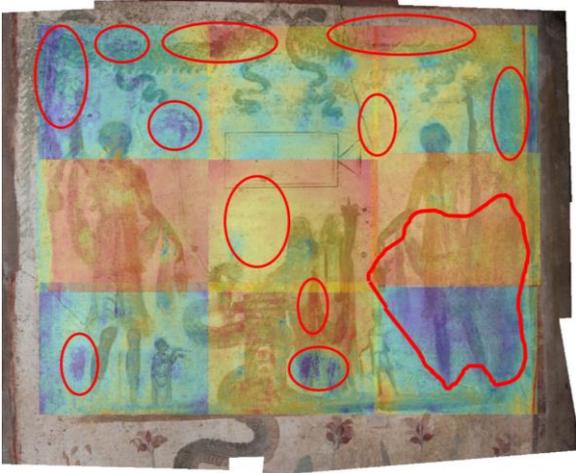
Fig. 6 PCA results for fresco P IX 13 3 3c O, partition IX

The first PC maps have been superimposed on the fresco visible image to allow an easier identification of the damaged areas, Fig. 6. The superimposition has been done using an on-site calibration procedure that made it possible to identify the match between the IR image and the visible one.

The peculiarities of the PCA do not allow having a map with fake consistent colors on all viewpoints: there are discontinuous colorations between the various viewpoints and the detachments appear with different colorations. In order to make the detached zones more intelligible, areas with a PC anomaly that may correspond to a detachment have been highlighted with red contour lines.

The measurement campaign made it possible to identify some detached areas of the frescoes analyzed, the most interesting one being the fresco P IX 3 13 3c O of the *Domus of C. Iulius Polybius*.
