Non-Destructive Assessment of a Historic Masonry Arch Bridge Using Ground Penetrating Radar and 3D Laser Scanner

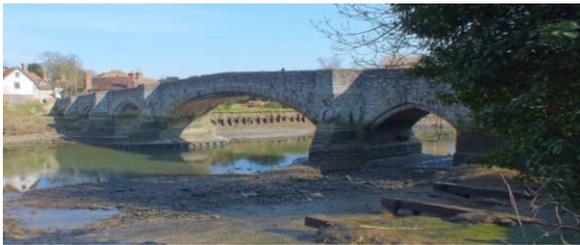
Fig. 1. The Old Bridge at Aylesford in Kent, UK.

Fig. 2. The Old Bridge: depiction of the survey zones.

The Old Bridge at Aylesford (UK) is a multi-span bridge dating from around 1250 (Fig. 1).

The system consists of two rows of eight double polarized 2000 MHz antennas with 10 cm spacing and allows scanning with a footprint 80 cm wide. The bridge deck was surveyed collecting four longitudinal scans spaced equally, that were performed along the length of the bridge. Transversal scans (i.e., scans across the bridge) were not collected. For data management purposes, the survey was divided into three ‘Zones’ (Fig. 2).

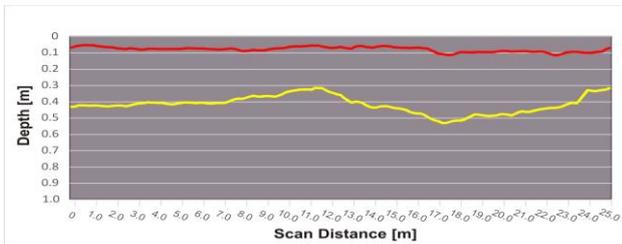
Fig. 4. Average total depth of asphalt (red line) and base layers (yellow line) within the bridge deck area.

Fig. 5. Layering of the asphalt (red line) and base layers (yellow line) within one scan in Zone 2.

Fig. 6. Reinforcing bars (in circles) identified using the 600 MHz GPR system.

The average thickness of the upper asphalt layer was 7 cm. The average total depth from the bridge surface to the historic stonework was 41 cm (Fig. 4).

The considerable variation in the thickness of both layers is shown in Fig. 5. This is likely related to the bridge's construction and the large areas of resurfacing identified.

With regards to the location of the ties, the 200 MHz and 600 MHz dual frequency antenna system was able to identify the reinforcing bars (Fig. 6). In case the location of these targets was unclear, cross-matching with the data outputs from the manual measurements and the laser scanner equipment were considered for the interpretation of the GPR data.
