Biodeterioration of wall painting at the UNESCO site of Varallo: pink patina.

Abstract – Chapel 11 at the Sacro Monte di Varallo, a UNESCO World Heritage site, is decorated with wall paintings and life-size statues. The wall paintings date from 1591 but were heavily repainted at the end of 19th century and again in 1955. Visual examination of the surface revealed the signs of possible microbiological growth (MBG). *In situ* investigations with portable microscopy (using visible and ultraviolet radiations) and with Adenosine Triphosphates (ATP) measurements were carried out to determine the presence of MBG and the level of their activities. Several types of MBG were identified, but this work discusses the main and more extended discoloration found: the pink patina. In laboratory, isolation and identification by 16S ribosomal RNA (rRNA) and internal transcribed spacer (ITS) sequencing were carried out to determine the species. The results obtained will be important for planning the remedial intervention, the post treatment monitoring and the maintenance processes.

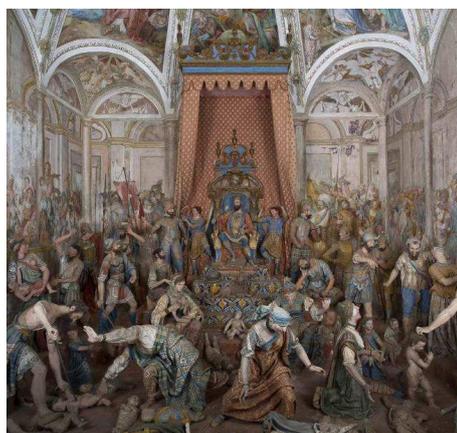
Fig. 1. Chapel 11, view of 'The massacre of the innocents' before conservation (Picture by Centro Conservazione Restauro "La Venaria Reale", 2012)

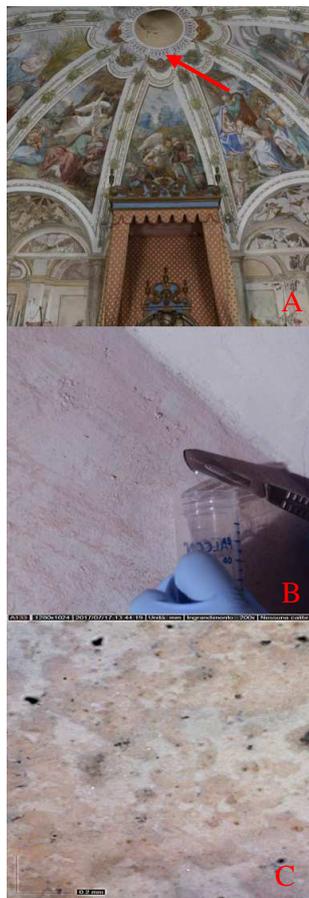
Visual examination of the wall paintings showed discolorations varying from white to pink (Fig.4) and brown patinas in some areas; dark spots were also detected. Some of these alterations were well delimited, while others, such as the pink patina, were visible on larger areas of the chapel, covered or not with paintings, suggesting the possible presence of microbial growth and/or microbial colonization.

Fig. 4. Pink patina. A: Area where the pink patina was visible, indicated with an arrow. B: point of sampling, C: image of the pink patina taken by Dino-lite, 200x.

Mapping of the discolorations, patinas and color changes showed that the most significant and diffused phenomenon was a pink patina, on which we focused our work.

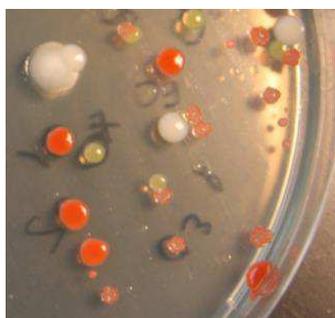
After 5-7 days, samples taken from the pink patina developed numerous dark pink and light pink bacterial colonies. Some white and yellowish bacterial colonies with diverse size and shape were also observed (Fig. 6). The growth of the pinkish colonies was higher in agar media containing NaCl, indicating the presence of halotolerant and/or halophilic bacteria.

Fig.6 Inoculated plate with powder sample of pink patina on R2A

We could also observe that the pink colonies were more abundant on R2A medium than on TSA or PCA without NaCl. This can be explained by the fact that R2A has a higher salt concentration than the other media. Moreover, R2A is recommended for the detection of slow growing microorganisms adapted to environments with low concentration of nutrients, as the conditions of the wall paintings.
