# A multidisciplinary approach to the safety assessment of the archaeological site of Pietrabbondante

In this paper, a multidisciplinary engineering approach is used for the archaeological site of Pietrabbondante; the issue of preservation of cultural heritage will be examined with reference to the environmental context where the site is located.

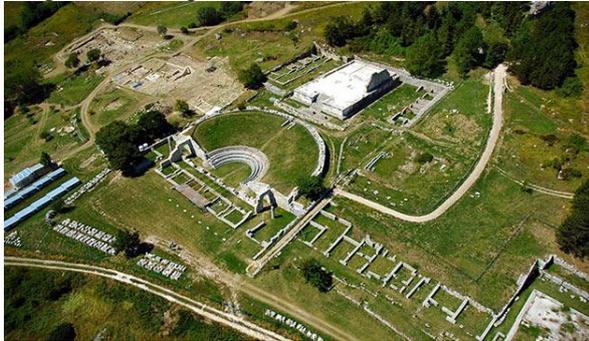
Fig. 2. Archaeological site of Pietrabbondante

In the 2nd century A.C., the alluvial soils covered completely the monument [9]; excavation activities, conducted in different phases, allow today to admire important structures out-of-ground, located in an extensive sacred area of seven hectares (Figure 2).

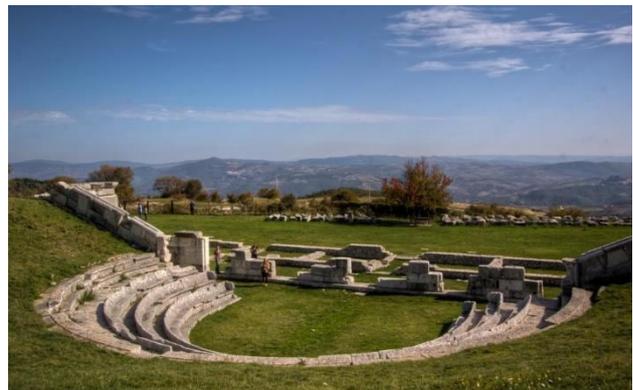
Fig. 3. Theater of Pietrabbondante

The Theater structure (Figure 3) uses the natural incline of the slope and it presents obvious affinities with Pompeii's Great Theater [13] for the planimetry layout, and with the *odeon* construction, for plastic and architectural decoration. An external polygonal wall, composed by large blocks, encloses the cavea; it is constituted, at the top, by six sections with a double row of seats, while at the bottom, three rows of stone seats are present.

The classic Hellenistic planimetry, characterized by a rectilinear facade and a division of the building into six environments with a perimetric corridor, is visible in the proscenium.

In addition, the natural conformation of the Theatre seats is threatened by not insignificant soil pressure, as can be seen from the Figure 6 a, a lot of instability phenomena are visible in the area.

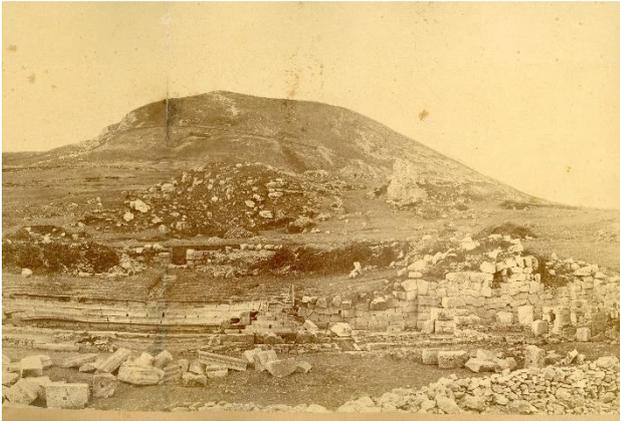
Fig. 4. View of the archaeological site in 1873 [17].

The Sanctuary of Pietrabbondante is located on an extremely vulnerable area. In according to the classification provided by OPCM n. 3274/2003, updated with the Resolution of the Regional Council of Molise of 2 August 2006 n. 1171, the area is classified as zone 2. The area was damage by a violent earthquake, probably in 346 A.C., after which many buildings were destroyed, and the area was abandoned. However, in the actual state, the historiography argues that the phenomenon of hydrogeological instability represent the principal cause of site deterioration. Conditions of instability, implicated by low mechanical properties of the soils, are aggravated by presence of runoff phenomena (see Figure 4); the erosive actions are triggered by intense and prolonged

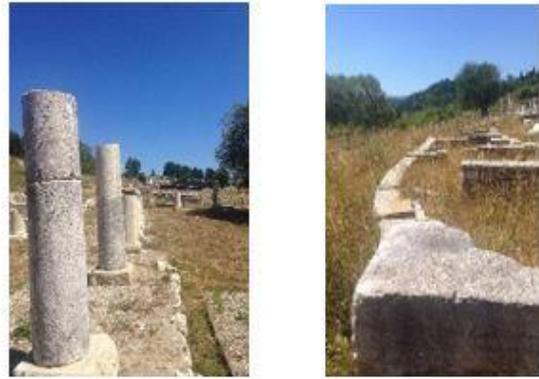
Fig. 5. Current state of colonnade, located in front of *Domus Publica* construction

Tangible signs of alteration are visible in the historic constructions; in particular on the *domus* colonnade (see Figure 5). The columns of central nave have lost their original alignment due to ground surface movements and differential land subsidence phenomenon at the base of the pillars. In this area, subjected by new excavation campaign in 2006, a continuous visco-plastic deformation is in progress; it involving considerable soil thicknesses; the deformation movement showed a greater activity, a lot of deformation have been observed in excavation faces and in the archaeological remains.

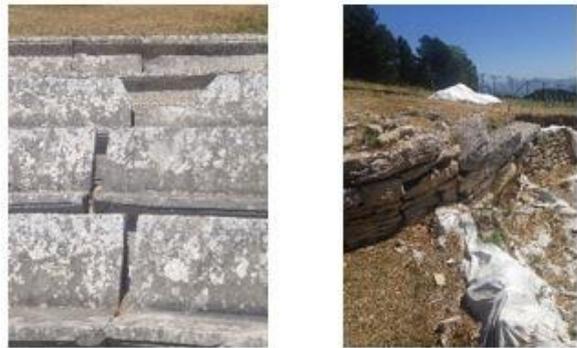
Fig. 6. Current state of cavea seats (a); Stone wall located in the northern part of the archaeological complex (b)

For example, Figure 6 b shows the actual state of a stone wall located in the northern part of archeological site.

Hydrogeological instability phenomenon, characterized by slow movements, have created considerable deformations in the *domus* areas and in the Sanctuary.
