A GPR Survey of the Floor of the São Carlos Theater (Lisbon, Portugal)

Abstract – This paper describes a study conducted by LNEC to assess the health and safety conditions of the floor of the Noble Hall of the National Theater of São Carlos. In a multidisciplinary approach, an extensive field work was carried out, involving the identification of type and location of floor beams in the various areas of the floor using a Ground Penetrating Radar (GPR), local inspection openings to visually assess the geometry, timber species and conservation state of structural members at those points and assessment of the conservation state of timber beam ends, using drilling equipment. The tests performed are referred herein, the potentiality of using GPR, the results obtained with ground- and air- coupled antennas are analyzed and recommendations are made.

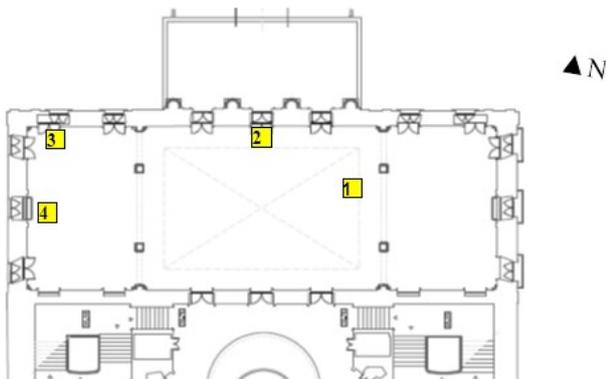
Openings for visual inspection were carried out at four points of the Nobel Hall pavement, through local cutting of the floor (see Fig. 2). The observations made allowed to confirm that the decorative floor rests on a flat multilayer structure (the total thickness of the several layers that make up the floor is about 50 mm), which contributes to the redistribution of loads and to the stiffness and bearing capacity of the floor.

Fig. 2. Draw of Noble Hall and location of the cutted samples.

The Noble Hall comprises three distinct zones: the central hall, of about 16.75m x 11.30m and the west and east areas, of about 7.75m x 11.30m each, with independent load-bearing structures. In the central hall, the floor structure consists of solid wood beams interspersed with metal beams arranged in the N-S direction. The wood beams, about 265mm high, have variable dimensions and spacing. In the east and west side, the structures of the floor are made of wood beams only, with variable sections and spacing from zone to zone, usually spanning between consecutive masonry walls.

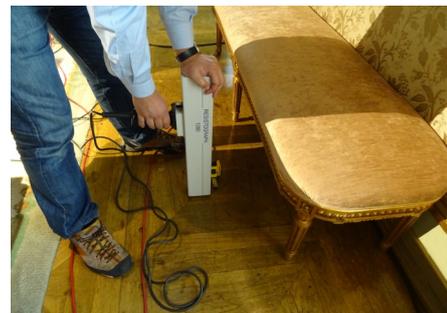
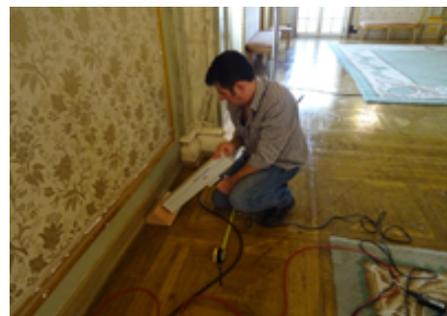
The procedure used consisted of obtaining a resistance profile from the area of the beams just outside the support zone (drilling at 90°), a location normally unaffected by biological deterioration related with moisture, followed by obtaining another profile in the support zone (drilling inclined at 45°) (Fig 3). The test points were decided based on the location of the beams, estimated using the georadar.

Fig. 3. Test of resistance to drilling: outside the support (on left); next to the support (on right).

The state of conservation of the support zones (ends) of some wood beams on the north façade was verified by evaluating their drill resistance with the IML RESI B 300 equipment. This equipment performs a hole in the wood with about 3mm in diameter, allowing to obtain a variation profile of the resistance to drilling along the cross-section of the element.

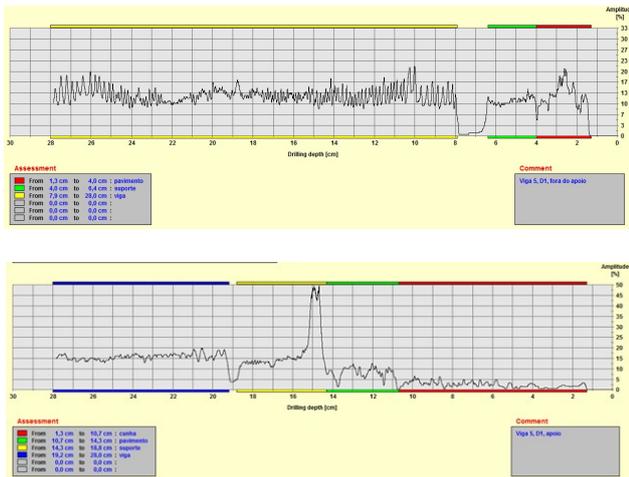
The results allowed to assume that the wood beams of the pavement are sound or without signs of significant degradation by fungi or subterranean termites. The differences in drill strength profile shown in Fig.4 are due to the difference between the needle inlet angle and the beam face (90 ° in the case of the test outside the supports area and 45° in that area).

Fig. 4. Results of Beam 5: outside the support (on top); next to the support (on bottom).

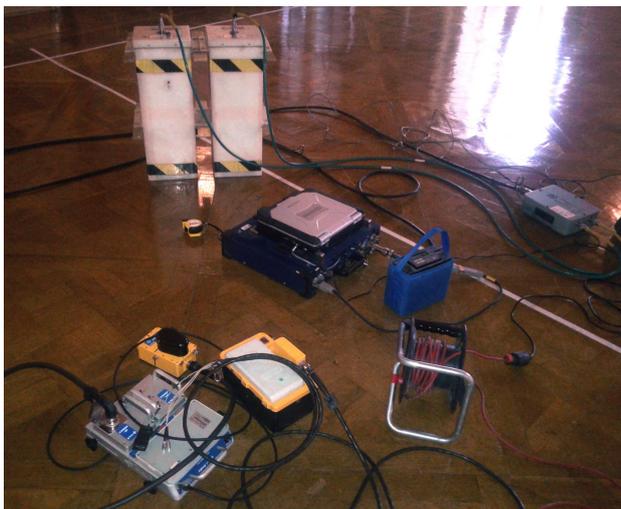
Different GPR systems were used including both ground- and air-coupled antennas (Fig. 5).

The ground-coupled system used was from Malå Geoscience company and it was composed of a Proex control unit and two bistatic antennas of 1.0 and 2.3 GHz. Data acquisition was carried out by distance with a trace-interval of 1.0 cm.

Fig. 5. GPR systems used.

The air-coupled system used was from GSSI company and it consisted of a SIR-20 acquisition unit with a bistatic antenna of 1.8 GHz. Data acquisition was carried out by distance with trace-intervals of 2.5, 1.0 and 0.5 cm (40, 100 and 200 scans/m, respectively).

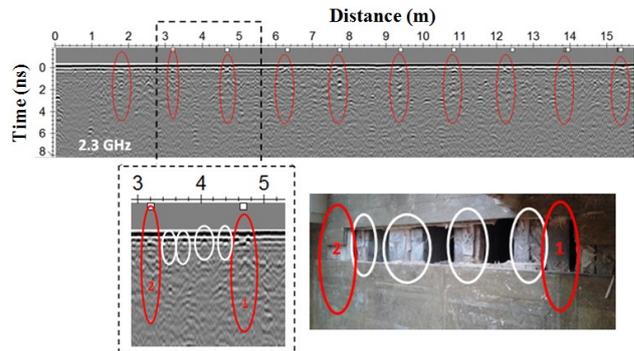
The data obtained with the ground-coupled antennas have produced radargrams with better resolution than the air-coupled antenna. Nevertheless, only the 2.3 GHz ground-coupled system has provided the configuration of either wood or metal beams (Fig. 6). The 1 GHz antenna presented a lack of detection in wood beams.

Fig. 6. 2.3 GHz data and detection of wood (white circles) and metal (red circles) beams.

The comparison between the 1.0 and 2.3 GHz ground-coupled antennas has shown that both frequencies present capabilities to detect metal, but only the resolution of the 2.3 GHz was able to detect all the wood beams.

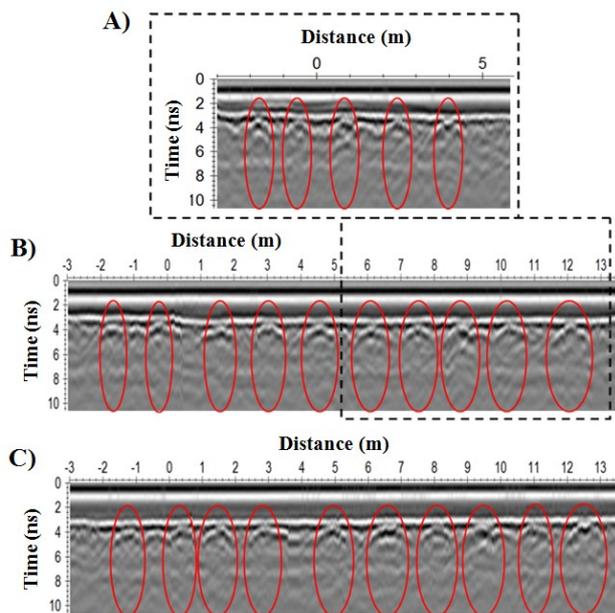
Observing Fig. 7, a data acquisition based on 100 scans/m displayed better results than using 200 scans/m, which was certainly produced by an overlapping of the hyperbolic reflections due to the excessive closeness between scans. On the other hand, a poor number of scans, as the 40 scans/m used in this work, presents the risk of losing detection.

Fig. 7. 1.8 GHz data with 40, 100 and 200 scans/m (A, B and C, respectively) and detection of metal beams.

Regarding the 1.8 GHz air-coupled antenna, although better results were obtained when considering 100 scans/m, the image resolution was worse than for the 2.3 GHz ground-coupled antenna.

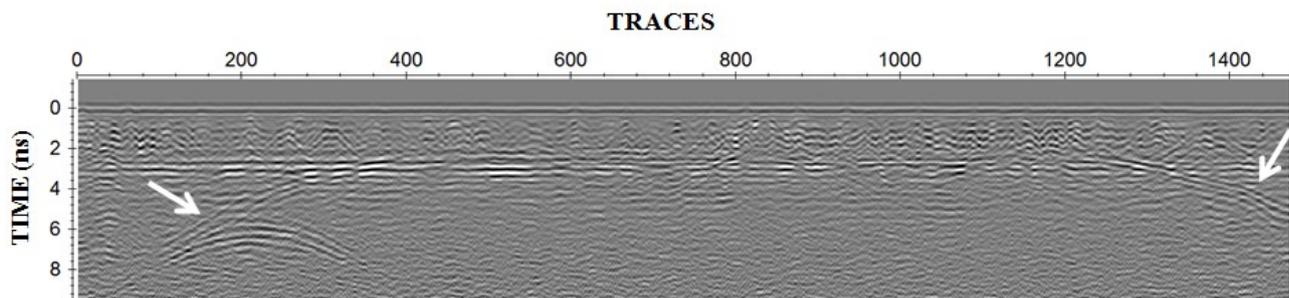
Additionally, several profile lines were acquired to determine the lower ceiling structure. Fig. 8 shows a radargram produced by the 2.3 GHz antenna in the longitudinal direction through the middle of the floor, which has revealed the existence of a centered vaulted skeleton. The data acquisition here was carried out by time, with a trace interval of 0.01 sec.

Fig. 8. 2.3 GHz data from the profile line acquired in the longitudinal direction at the middle of the floor.
