# Bond analysis of thermally conditioned FRCM-masonry joints

**Abstract** – Results of an experimental investigation on bond between thermally conditioned FRCM-masonry joints is presented and discussed in the paper. Single lap shear tests were conducted on clay brick specimens strengthened with different FRCM systems (basalt, steel and PBO-FRCM systems). Before testing specimens were thermally conditioned by exposure to different temperature values: 20°C (ambient temperature), 100 °C, 150 °C and 200°C. The thermal treatment was developed in this way: strengthened specimens were kept in oven and exposed to constant temperature over a period of three hours, then, they were removed and cooled down freely to ambient temperature. After the thermal treatment, specimens were tested at ambient temperature.

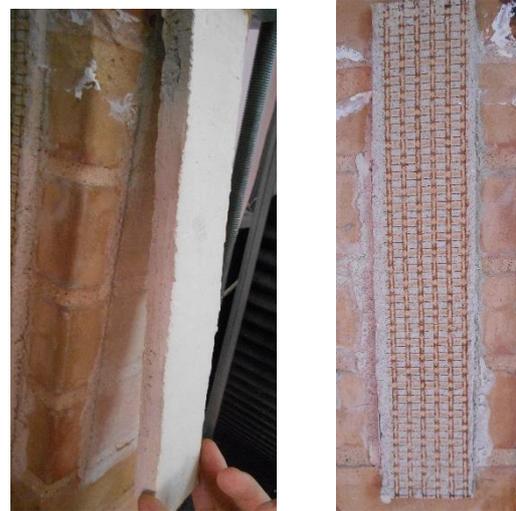
Fig. 5. Typical failure mode at 200°C: a) basalt B4 fibers, and b) steel S12.

It can be noted in Fig. 4 that specimens exposed at different temperature present a considerable reduction in terms of the peak load  $P$  and an increase of the global slip  $s$  (for the B2, B4 and PBO) if compared with specimens at ambient temperature. The reason is due to the drop of bond between the two layers of matrix and the fibers (Fig. 5a).

Instead for steel fibers, the global slip decreased with the increase of the exposure temperature. This is probably associated to the drop of bond between the masonry substrate and the composite strip (Fig. 5b).

It has been observed the typical failure of debonding both for the basalt B2 and B4 FRM systems and the steel S12 system. The failure was characterized by a sudden and brittle detachment of the fabric strip and external matrix layer. For all specimens, the interfacial crack formed along the fabric. Debonding occurred at the internal fabric-to-matrix interface and it was the result of fracture of the matrix between the fiber bundles.

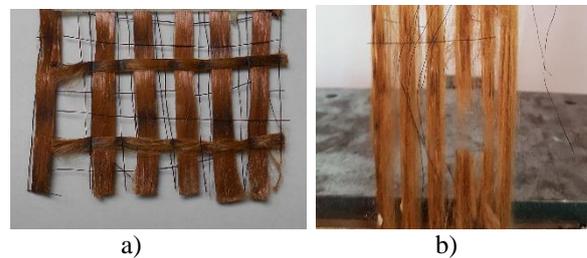
Fig. 6. PBO fiber at 200°C: a) after the exposition, and b) failure mode.

For the PBO fiber net, the typical failure modes show the slippage or the tensile failure of the yarns. In some cases, the combination of slippage and tensile failure of the yarns has been observed at same moment. Besides, the failure occurs in the reinforcement at the textile interface or yarn level, and the substrate or the reinforcement-substrate interface is not involved in the failure mode.

In addition, for the PBO fiber, the exposure at the 200 °C temperature caused a slight deterioration of the outer fabric (that outside the composite strip) and hence an atypical premature rupture for these types of fibers (Fig. 6).
