# Deformations and volume changes due to moisture variations in heritage buildings - Use of NDT techniques

José Dias<sup>1</sup>, Luís Matias<sup>2</sup>,  
Maria Henriques<sup>3</sup>

<sup>1</sup>National Laboratory for Civil Engineering, Buildings Department, *mirandadias@lnec.pt, Lisboa*

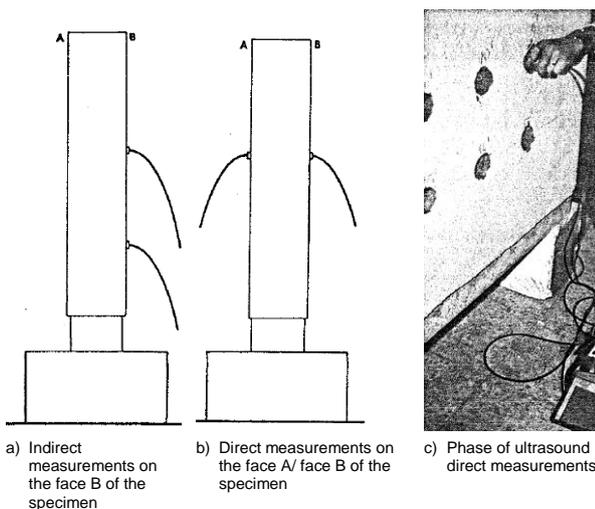
**Figure 1:** Indirect and direct measurements of ultrasound velocity on the face A and face B of the specimen, which was subjected to humidification during the rainwater permeability test

velocity were carried out. A first measurement was made a week after the construction of this wall specimen; 2<sup>nd</sup> measurement was made before the test of rainwater permeability of that masonry wall. That test started about 1 month after the construction of the wall, and lasted for 48 hours; and a 3<sup>rd</sup> measurement was made few hours after the end of the of rainwater permeability test, during which the specimen was moistened. Direct and indirect measurements were made in a frame of points (see Figure 1) deployed on each face of specimen, as shown in Figure 2.

A global analysis of these results revealed that it was possible to register some dominant trends in the evolution of ultrasonic velocity values. It was noted that, in general, since the 1<sup>st</sup> week after the construction of the wall, the direct measurements values decreased, until they reach a minimum before the test. After being moistened during the rainwater permeability test, ultrasound measurements taken in the specimen afterwards the end of that test, a generalized rise of direct measurements values was registered. This allows launching the hypothesis that the ultrasound velocity in direct measurements of that type of specimen was sensitive to changes of moisture content of masonry renderings. As regards indirect measurements, although it was registered, generally, a decrease of the values from the 1<sup>st</sup> week until the date that the test was performed, however, no dominant trend was detected in the evolution of the values, after the humidification of the face (B) subject during the test.

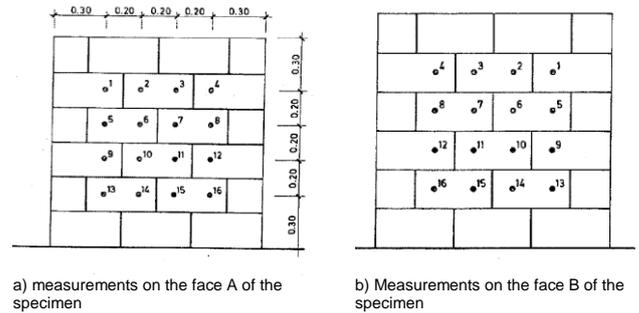
**Figure 2:** Schematic representation of the frame points for ultrasound measurements in the face A and Face B of the wall specimen.

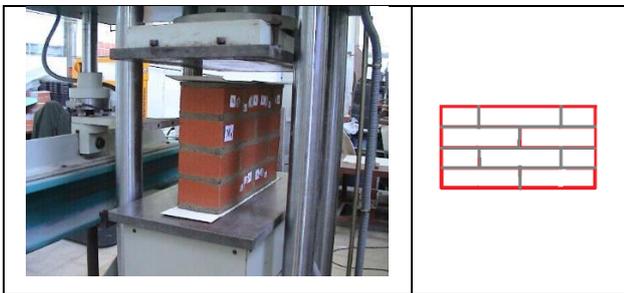
**Figure 3:** Specimen M1 before test (dimensions: 213 mm (length) x 108 mm (thickness) x 60 mm (height))

Specimen test M1 (Fig. 3) was built with massive ceramic blocks, which have average dimensions of approximately 213 mm (length) x 108 mm (thickness) x 60 mm (height), and cement mortar joints (cement sand ratio - 1: 4 / volumetric ratio).

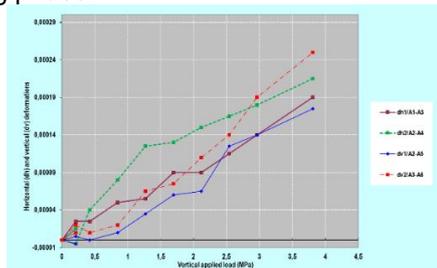
**Figure 4:** Deformations of the specimen M1 during 2nd loading phase for the vertical applied load

The results of the measurement of deformations with alongameter in specimens show that the variation of horizontal (A1-A3; A2-A4: see reading points in Figure 10) and vertical (A2-A5; A3-A6: see reading points in Figure 10) residual deformations, measured after discharge of the specimen, in end of each load step, were generally correspondent to a gradual expansion of the specimen (Figures 4 to 5); and can detect, with the increase of load, the gradual progression of cracking (see signs of cracking in Figures 9 and 10, which could affect, especially, measurement dv1/A2-A6 and dh1/A1-A3), that occurred in final part (after the 420 kN (8.90 MPa) of load) of the 3<sup>rd</sup> loading phase.

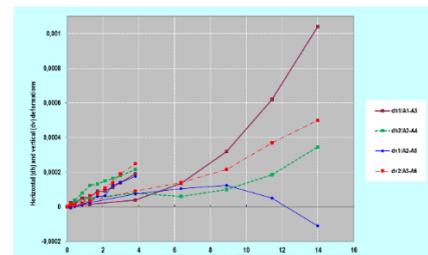
**Figure 5:** Deformations of the specimen M1 during the three loading phases for the applied load

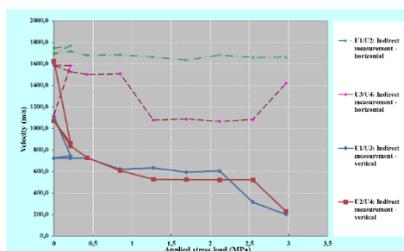
**Figure 6:** Ultrasound velocity (indirect measurements) of the specimen M1 during 1st loading and 2nd loading phase for the vertical applied load

Furthermore, these results reveal an almost constant decrease of the values of the ultrasound velocity (indirect measurements) in the 2<sup>nd</sup> and 3<sup>rd</sup> loading phases (see Figures 6 to 9), more in the vertical than in horizontal measurements, due presumably to the number of joints covered by vertical measurement (three mortar joints), that are higher than in horizontal measurement (one mortar joint or no mortar joints). Moreover, due, likewise, to the same effect, horizontal measurements generally are higher than vertical; and, in horizontal measurements, the U1/U2 velocity values (path with no mortar joints) are higher than U3-U4 values (path with one mortar joint).

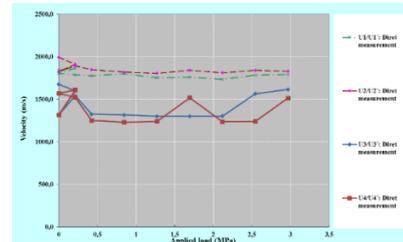
**Figure 7:** Ultrasound velocity (direct measurements) of the specimen M1 during 1st loading and 2nd loading phase for the vertical applied load

measurements show that, in the dry specimen, with the application of the first load step of 10 kN (1<sup>st</sup> loading phase), there was an increase of the ultrasound velocity measured after discharge of that load, relatively to the correspondent value for 0 kN, for all the measurements, namely horizontal (U1/U2 (path with no mortar joints); U3-U4 (path with one mortar joint) - see reading points in Figure 10) and vertical (U1/U3 and U2-U4 (path with three mortar joints) - see reading points in Figure 10) measurements. After the end of immersion of the specimen, the ultrasound velocity measured (indirect), for 0 kN, was significantly lesser than the correspondent value (for 0 kN) in the dry specimen - which indicates that the ultrasound velocity is sensible to the increase of moisture content (7.1% as was previously referred in 3.1). Subsequently, with the application of the first load step of 10 kN, in the 2<sup>nd</sup> loading phase, there was an increase of the ultrasound velocity measured after discharge of that load, for all the measurements, namely horizontal measurements (see Figure 6); in the direct measurements, similarly, a reduction of velocity value was observed, although only in U1/U1' and U4/U4', and it was less expressive than in indirect measurements (see Figure 7).

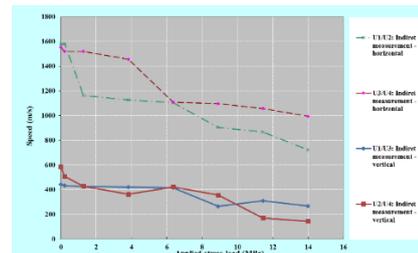
**Figure 8:** Ultrasounds indirect measurements of the specimen M1 during 3rd loading phase

In addition, for the same level of loads, some of the ultrasound velocity values (indirect) measured, in the 3<sup>rd</sup> loading phase, are higher (horizontal: U1/U2 and U3-U4 values) others are lesser, than the correspondent values of 2<sup>nd</sup> loading phase, due presumably to the significant decrease of moisture content (4.5% as was previously referred in 3.1), 6 days after the end of the immersion of the specimen. In the 3<sup>rd</sup> loading phase, an expressive reduction of velocity values was observed, particularly, with the gradual progression of cracking (cracking that affect, especially, U1/U2 velocity values (indirect) and U1/U1' (direct)) that occurred in final part (after the 420 kN (8.90 MPa) of load) of that loading phase.

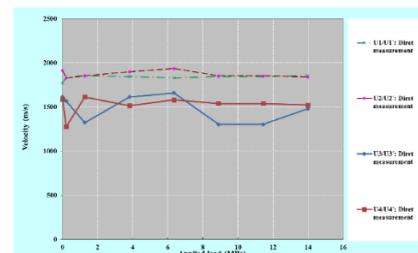
**Figure 9:** Ultrasound velocity (direct measurements) of the specimen M1 during 3rd loading phase

The results reveal a decrease of the values of direct measurements of the ultrasound velocity, for higher loads, in the 3<sup>rd</sup> loading phase, probably due to the correspondent increase of micro-cracks inside the ceramic blocks.

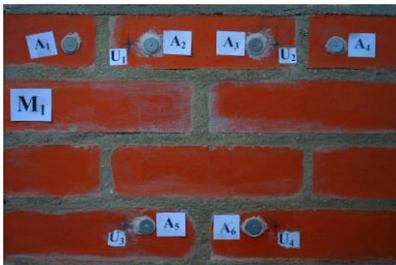
**Figure 10:** Orthomosaic of the surface. Pixel size 0.12 mm

Concerning the use in this test of photogrammetry, to generate an orthomosaic (image that is the result of stitching several orthorectified images) with a pixel of 0.12 mm it was necessary to make the photo survey with a high quality digital camera. Several photos were taken from different locations in front of the surface, but all at the same distance (70 cm). Digital image processing was applied to enhance the cracks. On Figure 11-A is presented

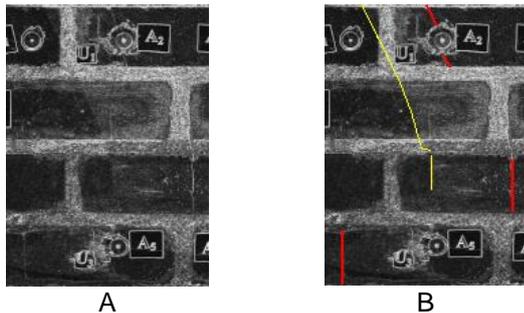
**Figure 11:** Detail of an image created by applying digital image processing tools to the orthomosaic (A). Edges coloured (B)

the result of the enhancement applied to the gray-scale version of the image. Two types of edges can be detected. These were manually coloured in Figure 11-B. In red the cracks, only perceivable in the bricks since the mortar presents great variability in intensity (is a heterogenous area, mixing pixel whites, blacks and grays). In yellow, the borders between two different images used to create the orthomosaic. These borders, barely perceived in the original orthomosaic, were enhanced also.
