## DEFECT DETECTION IN WIND TURBINE BLADE COMPOSITE BY USING INFRARED THERMOGRAPHY

Man Yong Choi\*, Hee Sang Park\*<sup>†</sup>, Jeong Hak Park\*, Yong Hak Huh\*

\* Korea Research Institute of Standards and Sciences:moonring@kriss.re.kr

**Abstract:** this study was conducted to investigate the nondestructive infrared-thermography assessment of composite materials for wind power blades, by simulating defects likely to occur during the manufacture and operation of blades and designing artificial quantitative-sized defects.

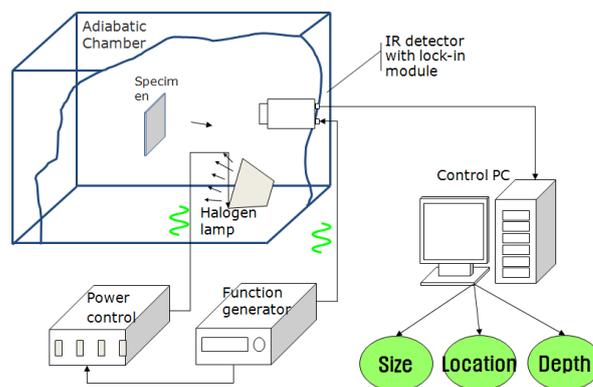
The infrared thermography device is composed of a heating device of light source and an infrared thermography camera, and to minimize the heat exchange with exterior heat source during the test, a testing apparatus was installed inside the insulation chamber as shown in Fig. 1. An light-source lamp with 1kW in output and 1m in distance was used, and the infrared camera was Silver 480m Model (NEDT: 25 mK) made by French Cedip. For a better detection sensitivity of the infrared camera, the surface of wind blade was coated with matt black paint to satisfy the same condition as absolute black body with 1 of emissivity.

**Fig. 1** System config of Optical infrared thermography

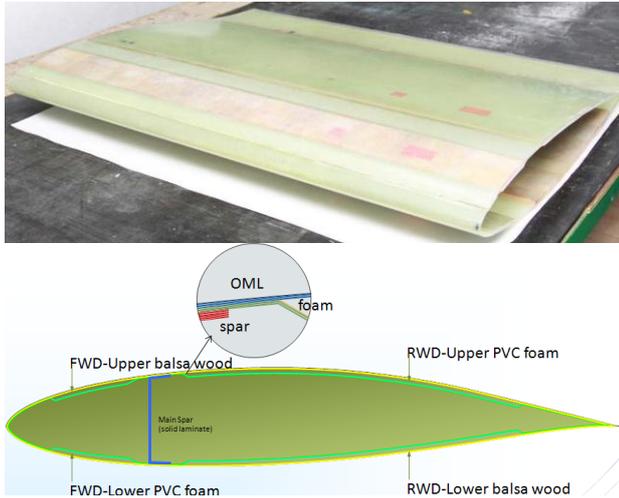
This study manufactured all the specimen by putting them into a chamber after laminating and molding prepreg through the vacuum processing. By using optical-infrared thermography and lock-in signal processing technique, this study carried out the detection of artificial defects prepared in each part of the blade. (Fig. 2 shows a shape of the specimen)

Fig. 2 Wind blade specimen

A wind power blade used for this study was manufactured in a form of NREL (National Renewable Energy Laboratory) S82X-series airfoil, applicable to a rotor 15~40 m in diameter and used GFRP as a reinforced material for the blade and epoxy resin as a glue, and the core was made of PVC foam and balsa wood. As artificial defects, the specimen were manufactured including inclusion defects with a copper sheet and a teflon film

inserted into each layer, void defects existing in parts where part are connected to each other.

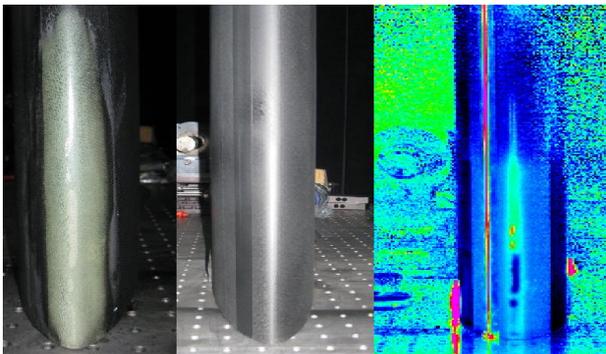
Fig. 3 is the results of infrared thermography for the frontal part of the blade, showing images of detected void defects existing inside the blade. In case of GFRP, defects may be seen with naked eyes, but in case of an actual blade, since the coating work is done in the final stage, it is impossible to detect inner defects with naked eyes. Although the coating work was not done in this experiment as it is done in an actual case, this study was able to detect void defects by spreading matt black paint on the material with infrared thermography, which are actually difficult to detect by spreading silver paint with infrared thermography.

The parts where defects exist are lead-edge parts where detecting defects is not easy with ultrasonic waves due to the characteristics of curvature, and especially during the operation, it is more difficult to detect defects.

Fig. 3 Void defect of blade lead edge

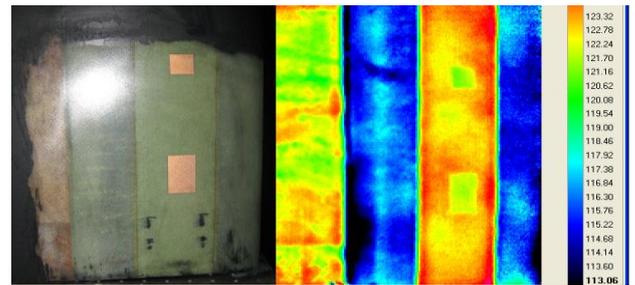
Fig. 4 shows a thermal image of the part where a copper sheet was inserted. Actually, the image of the surface part where matt black paint was spread was obtained through infrared thermography, and it was possible to detect inclusion defects that a copper sheet was inserted. Manufacturing artificial defects by using a copper sheet is a method that Boeing Company applies at present, and it is known to help grasp defects qualitatively and manufacture inner delamination as well. As a result of the infrared thermography, this study obtained thermal images regarding the growth ring of balsa wood and the adhesive state of resin, which would help confirm the adhesive condition of composite materials with balsa wood used as the core in the future.

Fig. 4 Inclusion defect of blade
